# INTERIOR DAMAGE AS WATER PENETRATES THE BUILDING ROOF

ID: 4924

Steel panels on the air handling unit deck

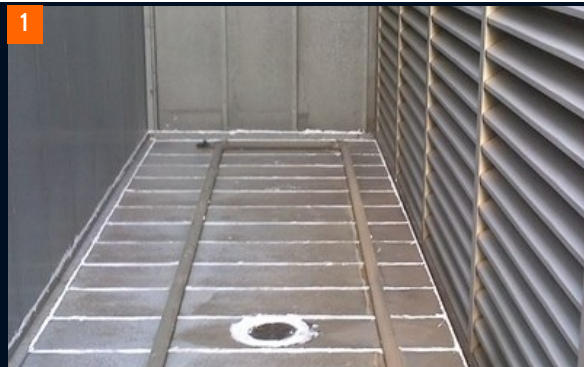
The joints between the panels on the air handling unit deck were not properly sealed. The deck is open to atmosphere and tends to accumulate water causing water to penetrate the building and damage interior walls.

1. Unit deck prior to application
2. Application underway
3. Alternate view of the application
4. Completed Application

Application was carried out in accordance with Belzona Know-How System Leaflet RPA-6. The surface was prepared by removing all the debris, dirt and stagnant water and abrading the surface to remove rust and create an anchoring profile. Belzona 3921 was applied as a first layer. Belzona 3111 was applied as a two coat system incorporating Belzona 9311 in accordance with Belzona Instructions For Use.
