# BELZONA PROTECTS NEW CHILLER

Chemical plant buying new chiller specified Belzona coating to protect their investment.

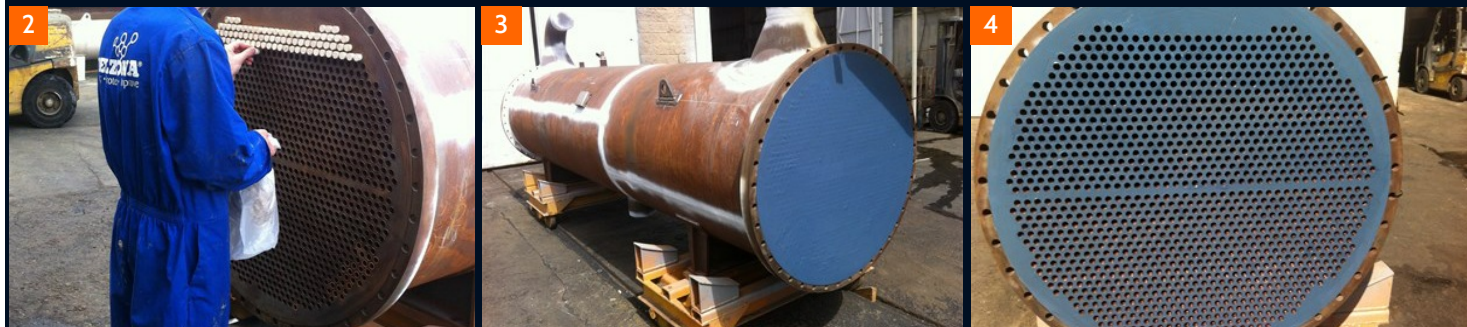
## PHOTOS

1. Tube sheet before application
2. Corking of the tube sheet
3. Tube sheet coated with Belzona 1321
4. Completed coated tube sheet

Application was carried out in accordance with Belzona Know How System Leaflets HEX-1 & HEX-3

Belzona 1311 (Ceramic R-Metal)  
Belzona 1321 (Ceramic S-Metal)
