# BELZONA RESTORES ELECTROLYTE PUMP BASES & CONTAINMENT AREA

ID: 4930

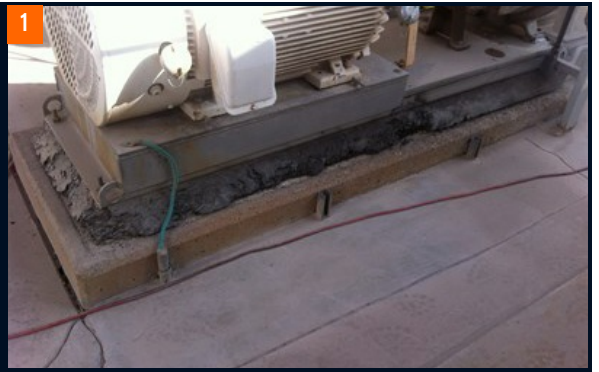
Leaking copper sulfate/electrolyte with 20 % sulfuric acid, has caused damages to the pump bases and containment area.

1. Damages to pump base caused by sulfuric acid attack
2. Damages to pump base repaired with Belzona 4131
3. Completed repairs to 3 pump bases & containment area
4. Final application of Belzona 4311 to prevent future chemical attack

The application was carried out in accordance with Belzona Know-How System Leaflets FPA-1 and FPA-3. Belzona 4131 was applied with a trowel. Belzona 4311 was applied utilizing a combination of paint brushes and rollers.
