# BELZONA PROTECTS ELECTROLYTE RECIRCULATION TANKS

ID: 4933

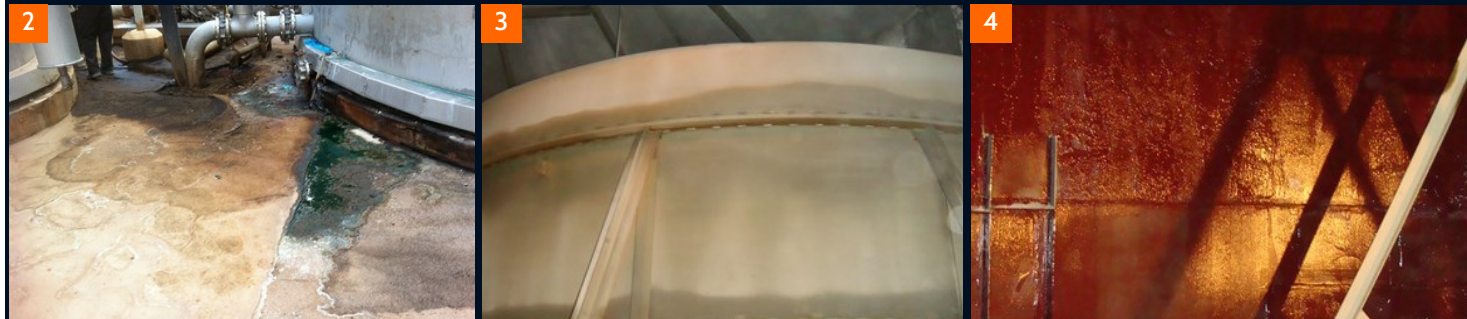
## PHOTOS

Electrolysis combined with chemical attack and metal fatigue were causing leaking at the weld seams of the tanks.

Copper sulfate (electrolyte) storage tanks experiencing leakage due to sulfuric acid attack at 120 °F.

The tanks had been experiencing leakage for years with the subsequent loss of product/copper sulfate as well as the extreme damages which were taking place on the concrete containment area surrounding the tanks.

1. Overview of the electrolyte recirculation tank
2. Tank leaking and deteriorating the concrete containment area
3. Interior tank walls prior to coating
4. Interior tank walls following Belzona 4341 application

The application has been completed in two tanks in accordance with Belzona Know-How System Leaflet TCC-3. The first one was carried out with paint brushes & rollers, and the second one was installed with spray application.
