# GARBAGE ROOM FLOOR REPAIR AND COATING AT A MALL

ID: 4936

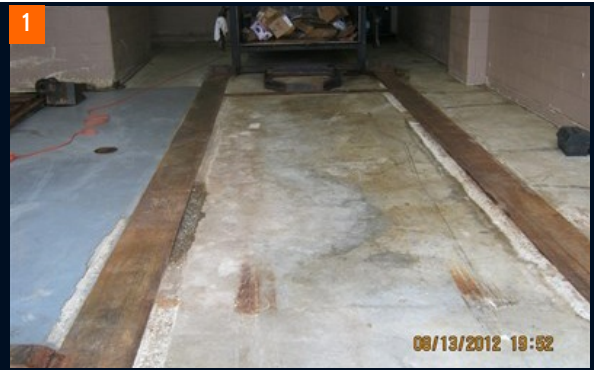
A combination of waste causing chemical attack and physical damage caused by large roll on, roll off containers.

1.Flooring prior to application  
2.Application in progress 3.Complete application 4.Eighteen months after application

Application was carried out in accordance with Belzona Know-How System Leaflet FPA-1. The surface was prepared by removing any existing coating and loose material or contamination and abraded to expose the aggregate. Belzona 4131 was applied to rebuild and repair the damaged concrete. Belzona 5231 was applied to the garbage room floor with a roller in accordance with Belzona Instructions For Use.

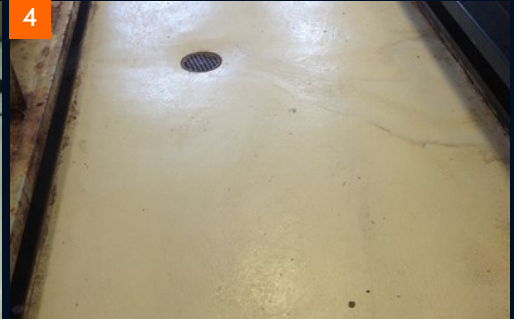
The repairs and coating provide resistance to the daily activities, wear and attack. Eighteen months after application (March 2014) the system is performing excellent.
