# REPAIR AND COATING FOR A BOILER FEED PUMP

ID: 4937

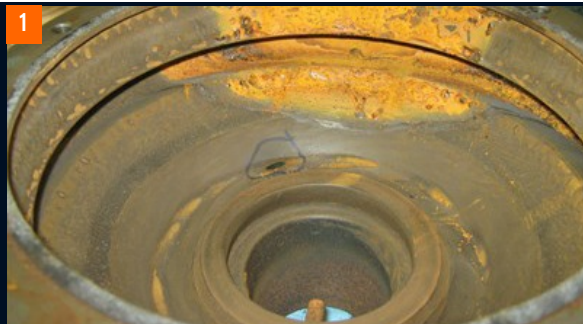
After 3 to 4 months in use the boiler feed pump was suffering from general corrosion/erosion and the metal shavings in the feed eventually would lead to a through hole in the casing.

1. Boiler feed pump prior to application
2. Preparation completed
3. Application completed
4. Fifteen months after application.

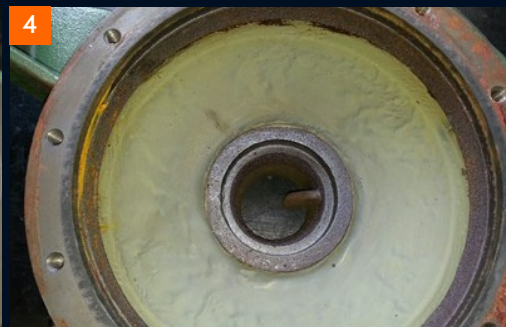
Belzona 1391 has been designed to operate under continuous immersion of temperatures up to 120°C (248°F) as the boiler feed was working at a temperature of 93°C (200°F). Fifteen months (March 2014) after application the system is in great working order with no corrosion/erosion or holes.
