# BELZONA REPAIRS GLASS LINED REACTOR

ID: 4940

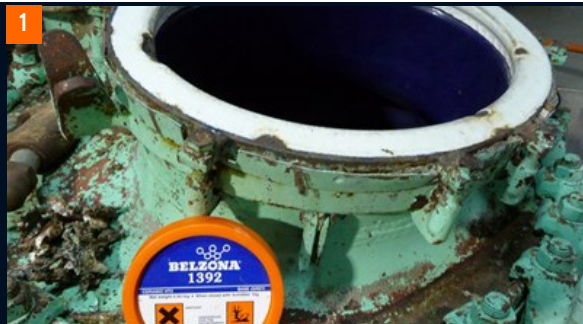
Chemical Reactor used to produce industrial cleaners and disinfectants. The process uses a mixture of acids and alkalis at an operating temperature up to 70°C.

1. The reactor
2. Damage on the paddle
3. Reactor damage
4. Completed reactor repairs

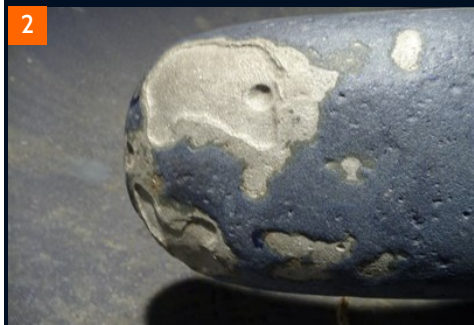
Due to the operational environment the glass lining in the reactor and on the agitator paddle was severely damaged exposing the base metal to severe corrosion.

Due to the extent of damage, especially on the paddle area, no other repairs alternative was available. The only option was replacing the reactor with new unit. The Belzona solution was completed on site and the unit was back to service in two days. The unit was inspected in 2012 and apart from slight erosion on the paddle was found in excellent condition.
