# BELZONA PROTECTS LIKE NO OTHER

ID: 497

Protect new containment for concentrated acid storage tanks

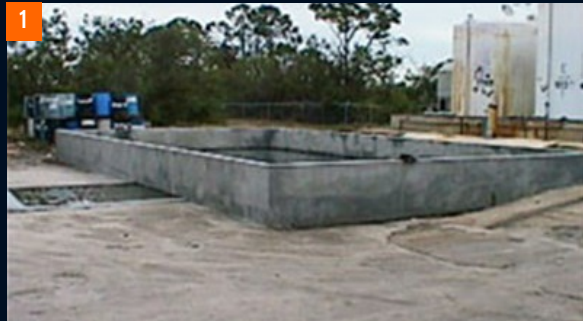
Old containment's rubber liner had failed from use and UV damage. Protection of new containment was required for continued use of acid mix down plant.

1. General view of the area
2. Belzona 4911 and Belzona 4141 applied
3. Belzona 4311 coat interrupted
4. Belzona 4311 applied over night, completing the application
