# BELZONA USED IN MAJOR REFURBISHMENT OF 75-YEAR-OLD DAIRY

An old, disused warehouse needed to be transformed into a cold store as part of a major refurbishment of the family run dairy.

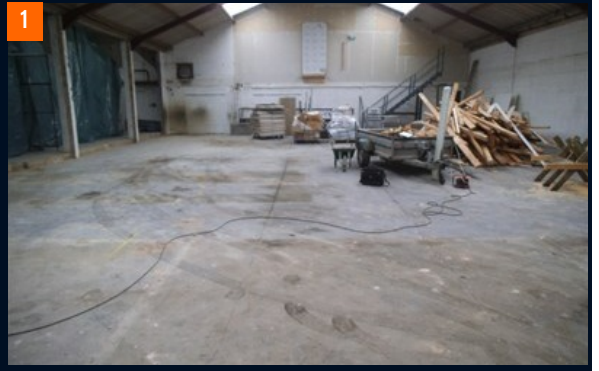
The dairy required several repair and maintenance solutions including localised repairs to the concrete floors, damage repairs to vertical columns, bonding on kerbstones and a non-slip, chemical resistant floor coating.

1. Disused warehouse before application
2. During application of Belzona 5231
3. & 4. Completed application

Application was carried out in accordance with Belzona System Leaflets FPA-1, FPA-3, FPA-11 and WPA-4. A slurry mix of Belzona 4111 was used to bond on the kerbstones. Belzona 4131 was used to repair several areas of concrete floor damage. The floor and kerbstones were coated with Belzona 5231. Belzona 4141 was used to repair damage to the vertical concrete columns.
