# BELZONA SEALS GLAZING BARS

ID: 4972

Glazing section on the roof of the residential building

Residential building, Croatia

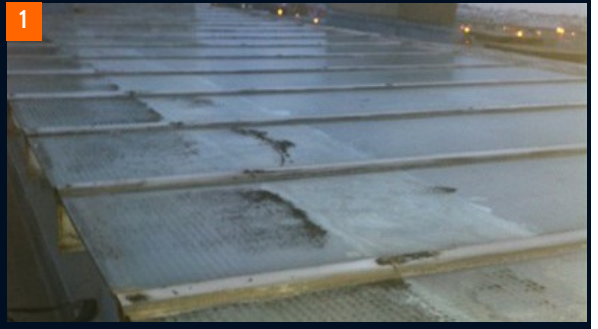
Water was penetrating the joints between aluminum frame and glass due to failure of the original sealant.

1. Damaged glazing section of the roof
2. Masking tape in place and Belzona 3921 conditioner applied
3. Application completed
