# BELZONA REBUILDS ERODED STERN TUBE SEALING FACE

ID: 4973

Stern Tube of container ship.

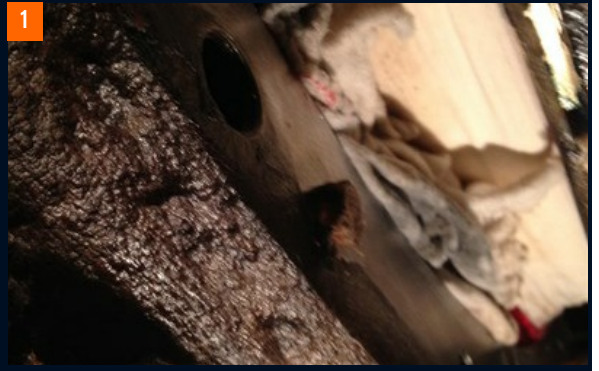
Galvanic corrosion damage on the boss sealing surface of stern tube system

1. Stern Tube with Galvanic Corrosion
2. Stern Tube after preparation with MBX Bristle Blaster
3. Stern Tube after applying Belzona 1311
4. Completed repair after polishing the Belzona 1311
