# SUCCESSFUL BELZONA REFURBISHMENT OF GUTTER

ID: 4975

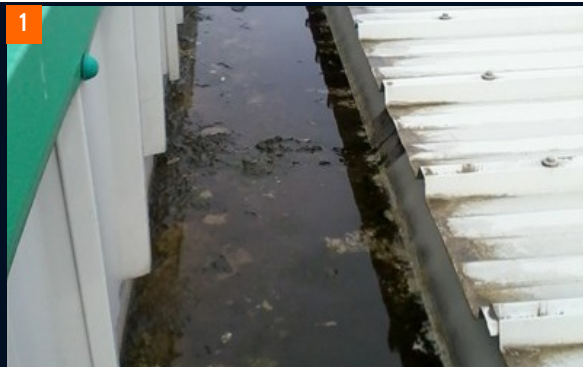
The client has had consistent water ingress issues from the aluminium gutters, despite repeated attempts to seal the gutter joints and seams with silicone and bitumen products. The showroom area has suffered water damage on a regular basis.

1. Gutters before application
2. Conditioner applied
3. Completed system
