# BELZONA REPAIRS AND PROTECTS 35 YEAR OLD CHILLER

ID: 4978

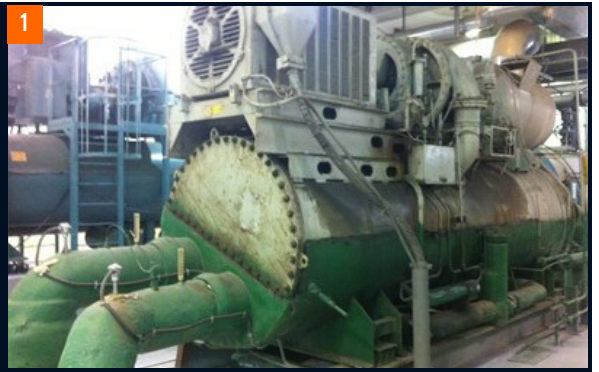
1. The York chiller unit
2. Tube sheet before application
3. Completed coating of the tube sheet
4. Close up of the coated tube sheet

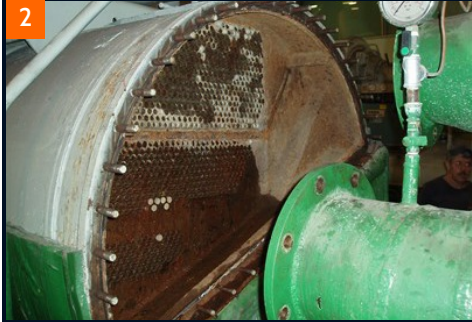
Tube sheet was badly corroded and gas leaks were occurring.
