# STANDING WATER - NOT A PROBLEM WITH BELZONA

ID: 498

Leaking gutters

Stainless steel gutters

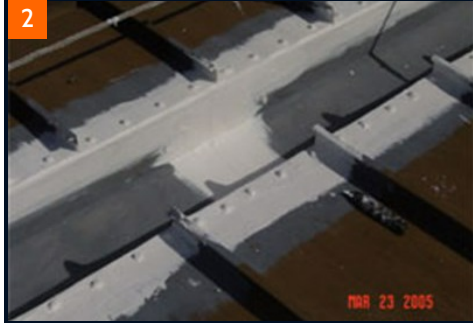
1. Gutters conditioned with Belzona 3921 and seams coated with Belzona 3111.
2. Seams coated with Belzona 3111.
3. First coat of Belzona 3111.
4. Second coat of Belzona 3111.

Application was carried out in accordance with Belzona Know-How System Leaflet RPA-7.
