# BELZONA SOLVES CHRONIC EXPANSION JOINT PROBLEM

ID: 499

San Antonio Airport, Texas USA

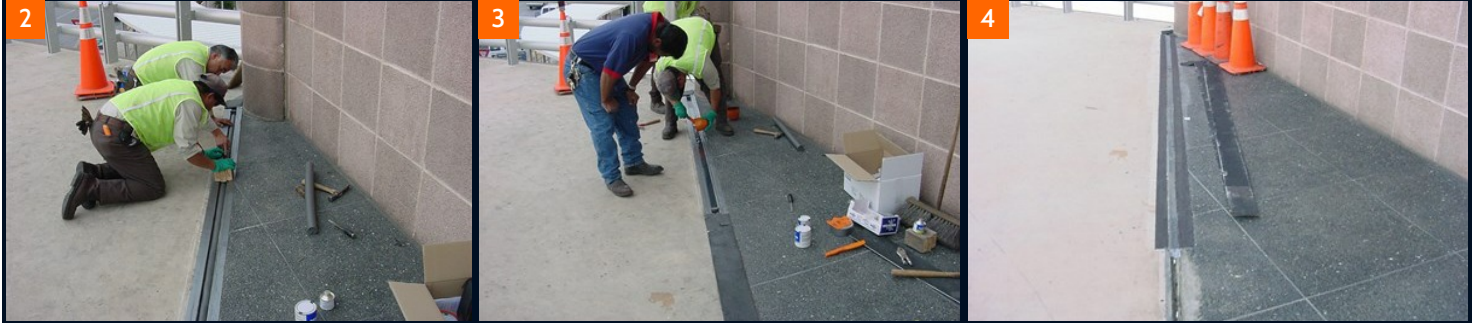
Previous repairs included steel covers over the joint. Then non-skid tape was added. Plates vibrated loose and along with the tape became trip hazard.

Expansion joint leaked water onto arriving passengers on floor below.

1. Joint before - showing old system
2. Backer rod inserted
3. Belzona 2221 being poured into joint
4. Finished joint with Belzona 2221 and Belzona 4411 (Note old steel covers and tape)

Application was carried out in accordance with Belzona system leaflet FPA-6 & FPA-8. Joint sealed with Belzona® 2221 system and Belzona® 4411 applied on both sides to provide neat, safe surface.

Client needed a durable, watertight, non-slip solution to this nagging problem. After three years of service, joints holding up well.
