# BELZONA REPAIRS CHIPS FROM THE OLD BLOCK

Chip cyclone

Lumber mill in Northern Ontario, Canada

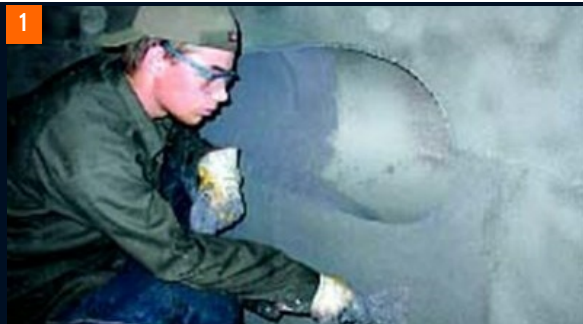
The cyclone's steel substrate was worn by continuous abrasion from wood chips entering at high velocity.

1. Prepared substrate and Belzona 1812 application to chip chute
2. Belzona 1812 being applied to the seams
3. Belzona 1812 being applied to the mid-section

The application was carried out in accordance with Belzona Know-How System Leaflets SHM-13, FBC-5 and TCC-1.
