# BELZONA FOR COOLING TOWER BASINS - EVEN IN COLD WEATHER

ID: 500

Cooling tower basin

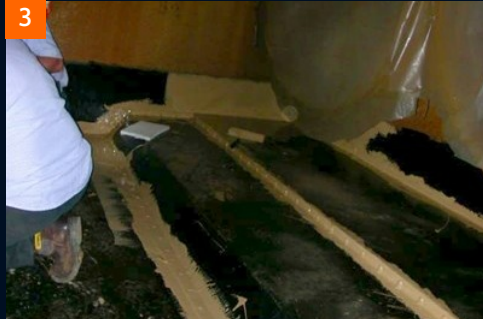
Lack of protective coating allowed for leaks to develop.

1. Side of tower, showing opening
2. Interior, corroded
3. First coat of Belzona 5811
4. Final coat of Belzona 5811 - ready for service

After postponing repairs for 4-5 years, the basin was leaking enough to force the issue. After surface preparation by grit blasting, there were many pin holes, but all were too small to allow the Belzona® 5811 to leak through so an impervious surface was achieved. Two cooling tower basins were protected in cold weather by placing heaters below the basin, and a tarpaulin across the top, so raising the interior temperature to 65°F (18°C).
