# BELZONA FLEXIBLE MEMBRANE KEEPS TURBINE ROOM AND CONTROL ROOM DRY

ID: 501

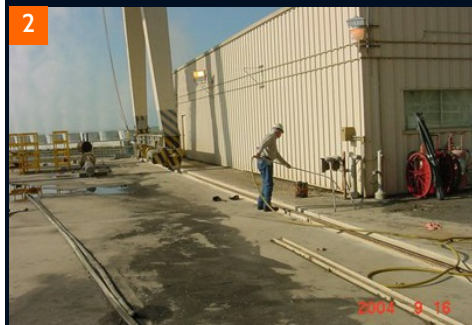
Water ingress to control room through walls and into turbine room via failed sealants.

Customer needed cost effective way to stop rain water intrusion into vital operating areas. Worn out sealants on turbine room roof and control room walls allowed wind driven rain to enter these critical areas. Repair needed to be customized to fit unusual shape.

1. Overview of control room wall area and crane track
2. Cleaning out old sealant and failed imitator products
3. Belzona 3921 (GSC Surface Conditioner) applied
4. Completed repair
