# SEVERE CORROSION STOPPED WITH BELZONA 3111 (FLEXIBLE MEMBRANE)

ID: 502

Lime slurry reclaim tank. Client needed a long-term repair to an unusual corrosion problem.

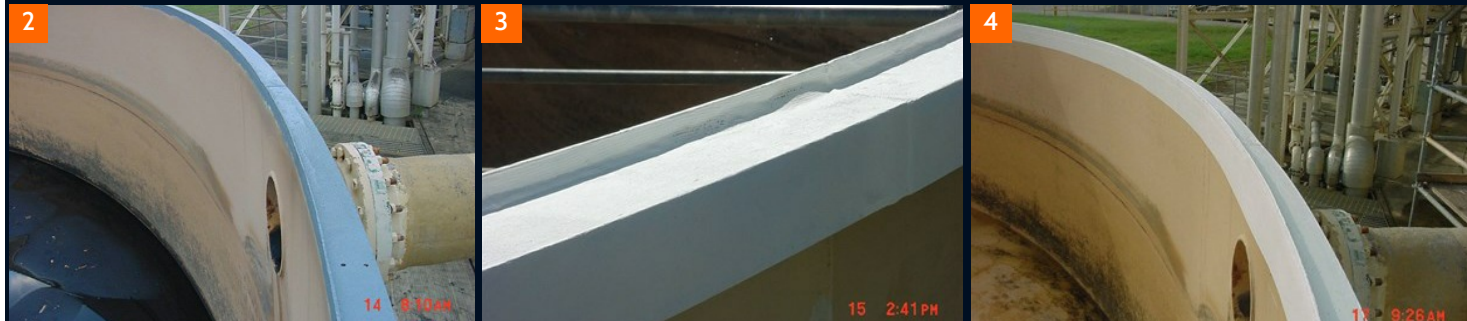
Severe corrosion caused paint delamination on top of exposed reclaim tank walls.

1. The corroded reclaim tank wall.
2. Surface prepared and conditioned with Belzona 3921.
3. First coat of Belzona 3111.
4. Top coat of Belzona 3111 applied.

Belzona 3111 (Flexible Membrane) has been successfully used in other parts of plant. Repeated painting and repainting did not provide long term relief. Areas was grit blasted to remove old paint and other products which had failed.
