# BELZONA 9811 EXTENDS SERVICE LIFE OF FLOP GATE AT CEMENT PLANT

ID: 5024

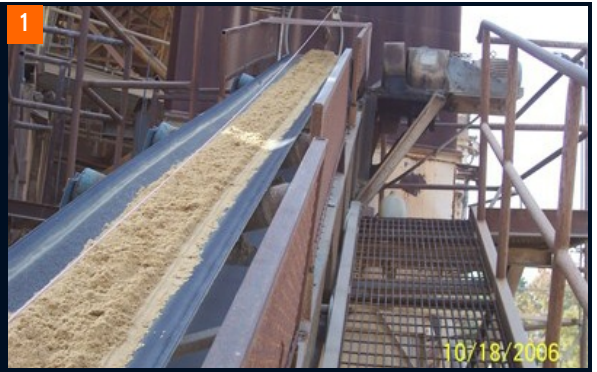
1. Quickcrete mixture on the conveyor belt
2. Flop gate repair completed
3. Flop gate repair close up
