# BELZONA 2111 (D&A HI BUILD ELASTOMER) SAVES UTILITY

ID: 503

Rubber lined lime slurry tank

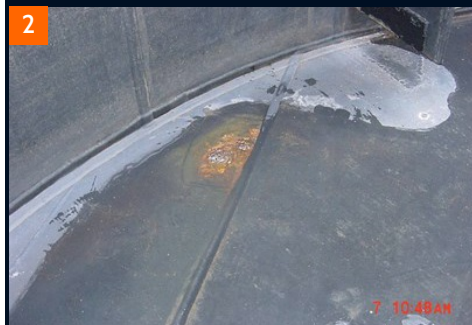
Inspection revealed severe corrosion in spots on floor. Customer needed fast, cost effective repair.

1. Lime slurry tank showing corrosion in rubber liner
2. Another view of corrosion
3. Close up view of corrosion
4. Belzona 2111 patch complete

Hot vulcanization and liner replacement had been considered but were judged too time consuming and costly. Belzona® 2111 was chosen for its great abrasion and chemical resistance, as well as its ease of application. Repair still in excellent condition after three years of service.
