# BELZONA REPAIRS DAMAGED CONCRETE FLOOR

ID: 5059

About 28m<sup>2</sup> of concrete floor in textile plant exposed to regular forklift truck traffic.

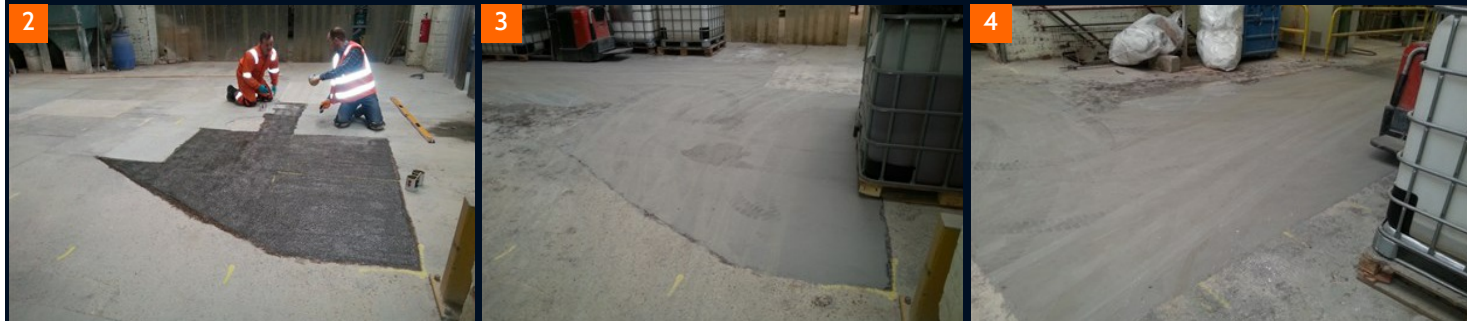
## PHOTOS

The floor was suffering from heavy wear in localised areas due to the heavy forklift truck traffic present on the site. This had caused damage to numerous areas of the concrete with a loss of depth in some areas of up to 10mm.

Damaged concrete floor Application of Belzona 4111 & 4. Completed repair

Application was carried out in accordance with Belzona Know-How System Leaflet FPA-1. A mechanical plane and cutter were used to remove the concrete substrate in the designated areas down to a minimum depth of 6mm before it was conditioned with Belzona 4911. The surface was then rebuilt with Belzona 4111 finishing flush with the surrounding areas.
