# BELZONA PROTECTS STADIUM

ID: 506

St. Louis University, St. Louis, Missouri  
USA

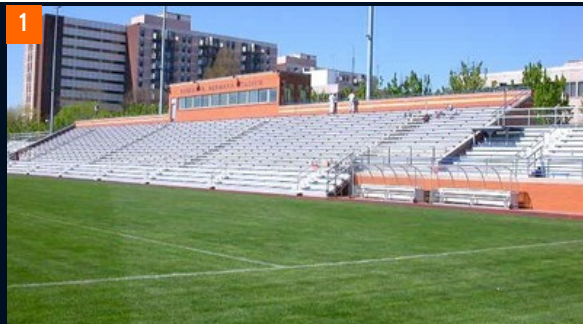
Wall caps had deteriorated to the point of either needing repairing or replacing.

1. Overall view of stands
2. Close up of typical damaged block
3. Completed south wall area
4. Completed north wall area

Replacement cost in this situation was astronomical; the Belzona solution offered a cost effective alternative. The Belzona® 3111 was tinted to match the color of the original stone.
