# BELZONA COLD PLATE BONDING ON BULK FUEL HOLDING TANK

ID: 5062

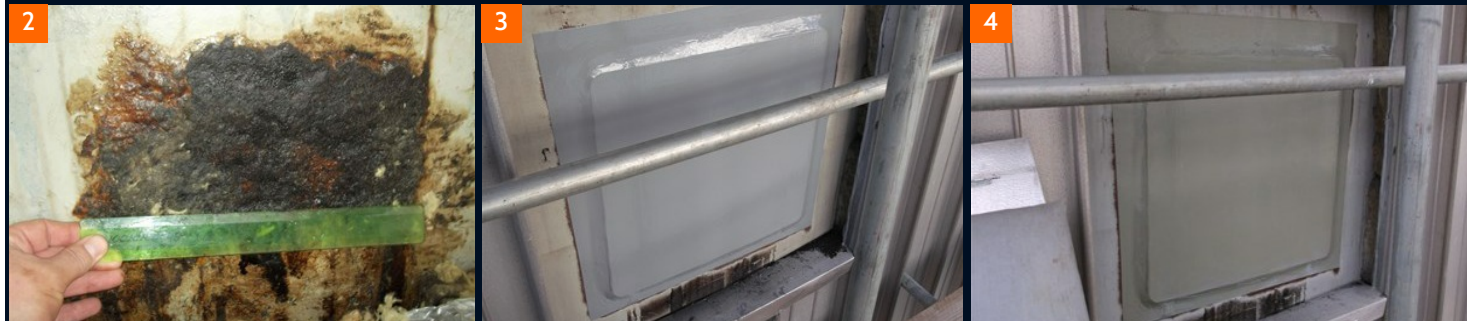
## PHOTOS

Insulated bulk holding tank containing heavy fuel oil. Corrosion under insulation had led to a through wall penetration at approximately 8m above ground level.

1 & 2. Original side wall tank hole/leak area

3. Completed application February 2013

4. Application checked April 2014

Due to the urgency, Belzona were quickly mobilised and prepared the substrates by grit blasting to the desired standard, bonding a 500x500x5mm plate using Belzona 1161 and final two coat system Belzona 5811 in accordance with Belzona System leaflet TCC-3.
