# BELZONA SEALS LEAKS IN GLASS BLOCK WALL

External glass block wall at entrance to University

St. Louis University - St. Louis, Missouri  
USA

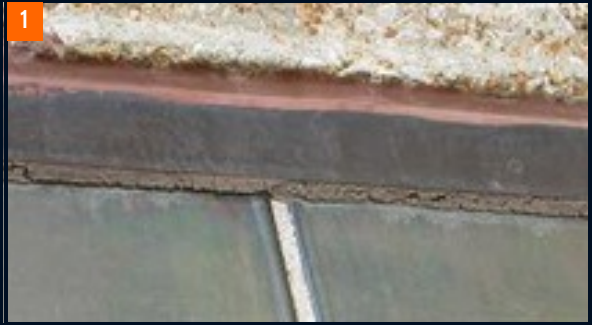
Severe leaks causing interior damage to the ceiling and walls.

1. Close up of deteriorated calking
2. Overall view on east wall
3. Completed east wall
4. Completed south wall

Belzona® 3111 was applied from the top of the glass over deteriorated and leaking calking and attached to the concrete wall at the top. Over the last few years, several contractors had worked on the wall at great expense without solving the problem.
