# LIFTING DEVICE FOR FENDER

ID: 508

## PROBLEM

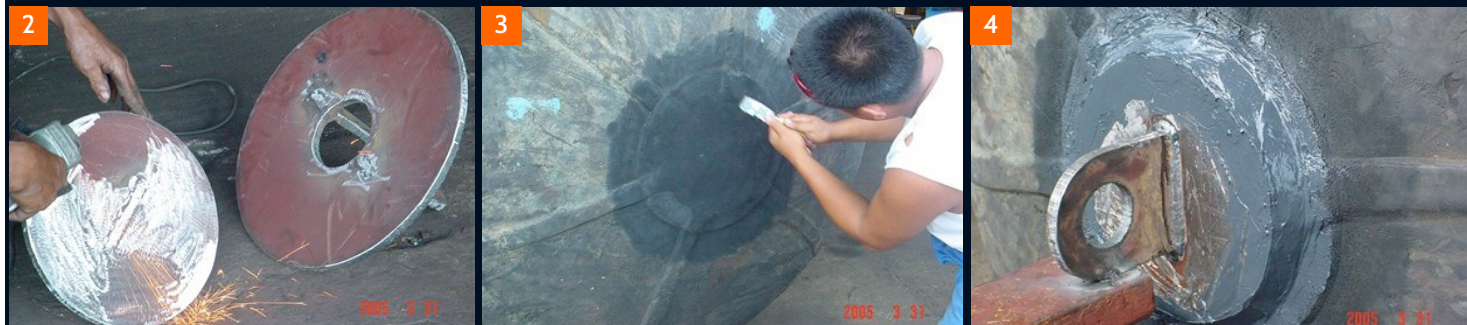
## PHOTOS

1. Fender without lifting device
2. A 12" diameter plate is prepared with lifting hook
3. Surface preparation for the fender
4. Finished application – metal lifting device is attached to the fender

Attaching metal lifting device to 800kgs rubber fender

The application was performed in accordance with Belzona Know-How System Leaflet SOS-12.

Previously, fenders are wrapped with tires tied with metal cables. On rough seas, ships paints get damaged by the metal cables. Putting a metal lifting device using Belzona® Elastomers was the right solution.
