# BELZONA RESOLVES WATER INGRESS ISSUES FOR FOOD SUPPLIER

ID: 5082

Flat roof over chilled food processing plant.

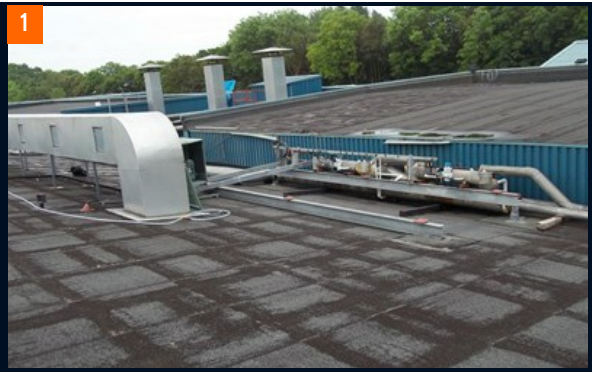
Months of inclement weather had resulted in several cracks in the felt roof, leaking gutters and damage to the parapet walls, each resulting in leakage through into the packing area below.

1. Roof area suffering water ingress
2. Leaking guttering
3. Gutter sealed with Belzona 3131
4. Completed area

The application was carried out in accordance with Belzona System Leaflets RPA-1, RPA-6 and RPA-11. After carrying out thorough surface preparation including removing all loose substrate matter and treating with a fungicidal wash, a fully reinforced Belzona 3131 system was then brush applied to the entire roof area.
