# BELZONA RUBBER LINED VALVE REPAIR

ID: 5086

Water control valve

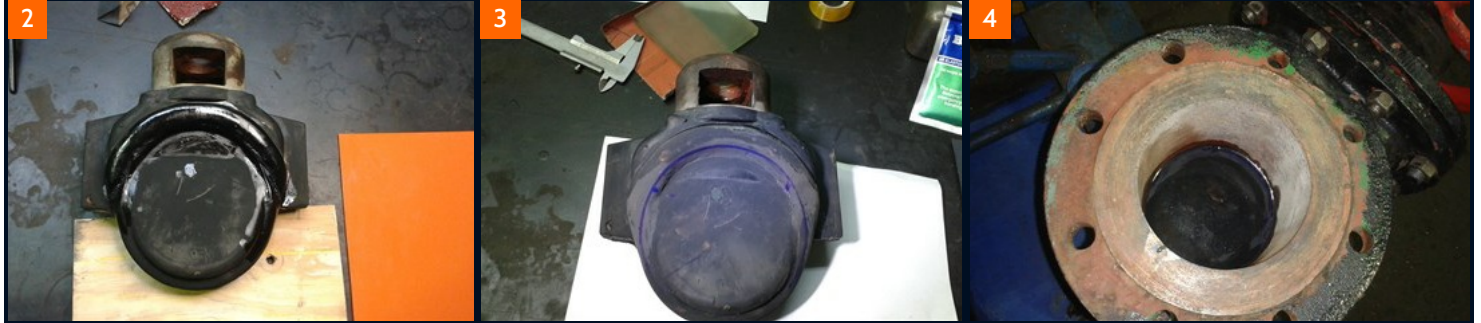
Valve sealing surface had deteriorated over the years causing inefficiency in stopping flow of water

1. Valve damage marked up
2. Prepared surface
3. Belzona 2311 application completed
4. Assembled valve to undergo pressure test

Application was carried out in accordance with Belzona Know-How System Leaflet VPF-5

Belzona repair was cost effective and allowed valve to be quickly returned to service. Fast curing Belzona 2311 was only solution available to the customer in the downtime available.
