# BELZONA REPAIRS AND PROTECTS CENTRIFUGAL PUMP HOUSING IN AN INDUSTRIAL MINE

ID: 5088

Reconstruction and abrasion-resistant lining of the pump housing of the mud conveyor.

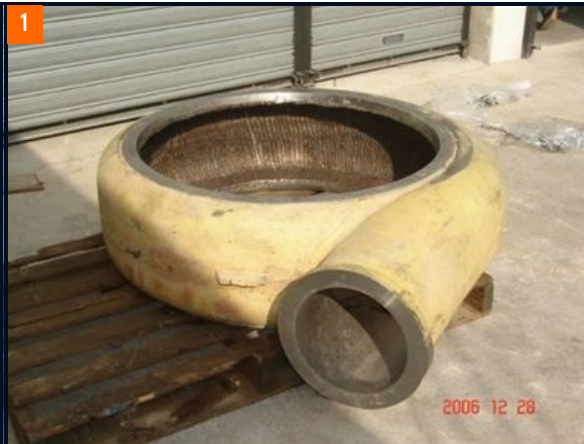
1. Centrifugal pump housing
2. Holes due to severe abrasion
3. Application of the lining
4. Application completed

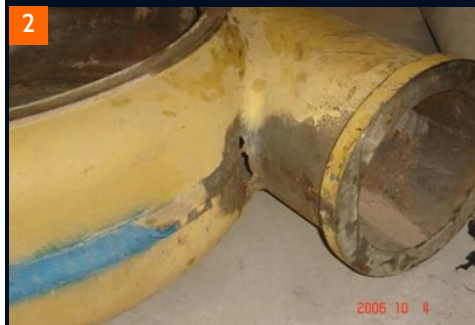
Due to the severe abrasive conditions caused by the suspended solids, the pump casing was severely stripped and holes appeared in the housing.
