# BELZONA RESTORES VACUUM PUMP AFFECTED BY DEEP EROSION

Interior of the central casing of a large liquid ring vacuum pump

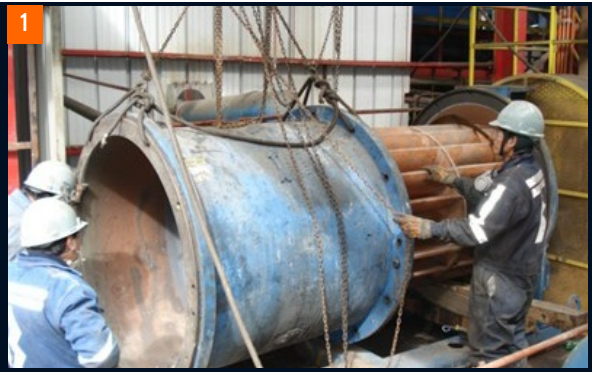
1. Disassembly of components
2. Grooves caused by erosion all around on both sides
3. Refilled with Belzona 1311
4. Reconstructed area was later covered with Belzona 1341.

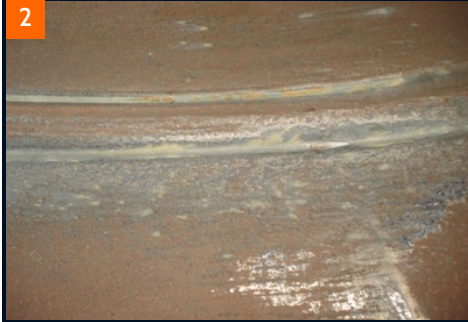
Seal water drags solids deeply eroding the central body all around, on both sides of the central ribbing weakening the casing and even making a hole at one point.
