# BELZONA SEALS COOLING TOWER AT GOVERNMENT BUILDING

ID: 509

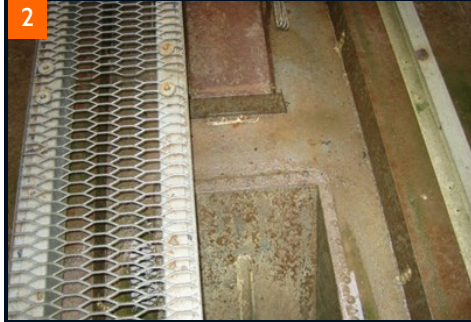
1. Exterior image of cooling tower
2. Interior image of the problematic cooling tower
3. Belzona 5811 applied
4. Another shot of the cooling tower, ready for service
