# BELZONA COATS THE EXTERIOR OF AN ACID PUMP

ID: 5090

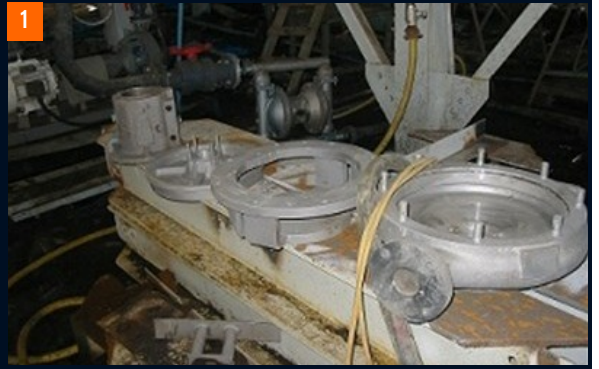
The acid spilt onto the pump, which caused the equipment to be removed from service and the pump did not last as long as the mine wanted to.

1. First blasting of the pump
2. Second blasting, ready to apply the coating
3. Application of Belzona 4311
4. Pump coated with Belzona 4311

The pump was blasted to white metal to eliminate the acid contained in the substrate. Then, two coats of Belzona 4311 were applied to the external part of the pump.
