# BELZONA PROVIDES FAST INTERIOR PROTECTION OF TWO CYANIDE DESTRUCTION TANKS

ID: 5092

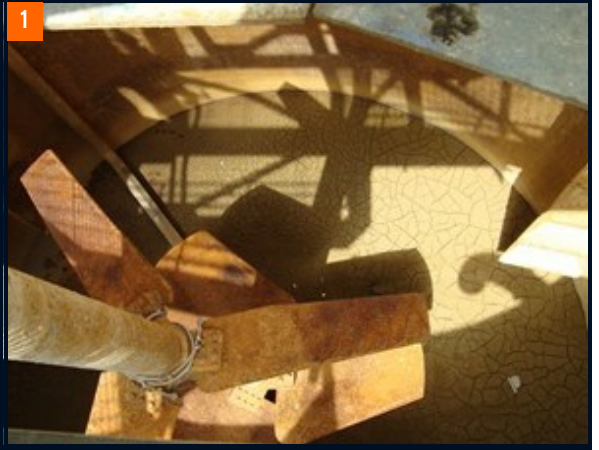
Aggressive chemical attack, cavitation and erosion of suspended solids in processing tanks that operate with permanent entry and exit of fluids and mixing blades.

1. Original conditions in the interior of the tank
2. Image of the tank and airless spray equipment
3. Mixing Belzona 4151
4. Application completed

After blasting, Belzona 4151 was applied with airless spray equipment in accordance with Belzona Know-How System Leaflet TCC-5.
