# BELZONA REPAIRS THE GRIP OF A CONVEYOR PULLEY

ID: 5093

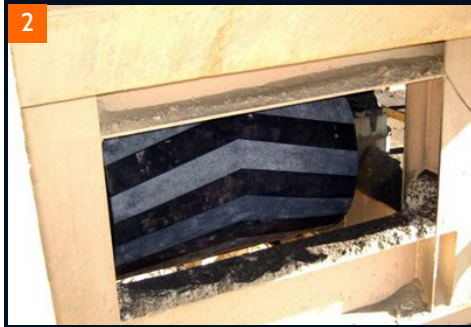
Due to moisture problems, the conveyor belt slipped from the pulley, burning the coating, which led to loss of grip.

1. Damaged pulley
2. Drawings on the pulley, applying Belzona 1321 and Belzona 9211
3. Pulley coated with Belzona 1321 and Belzona 9211
4. Application completed

The areas where the application was to take place had been marked in a chevron pattern. To achieve this, a gummed paper was used and then the surface was prepared, in order to obtain the highest roughness possible to start application of Belzona 1321 and Belzona 9211 products. Application carried out in accordance with Belzona Know-How System Leaflet SHM-12.
