# CORRODED AND CRACKED PIPEWORK FIXED WITH BELZONA

ID: 5106

Pipework at global paints and coatings company.

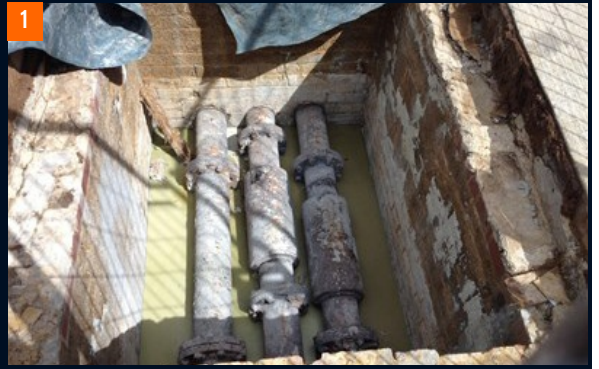
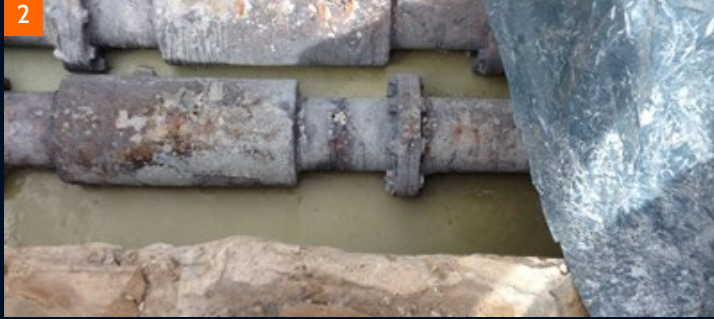
The pipe had corroded and cracked, leaking 10% Sodium Hydroxide.

1&2. Cracked and corroded pipework

Application was carried out in accordance with Belzona System Leaflet VPF-11. Surface preparation was carried out using an MBX Bristle Blaster as grit blasting was not an option. After stemming weep, the pipe was wrapped with Belzona 1161 incorporating Belzona 9341 (Reinforcement Tape).

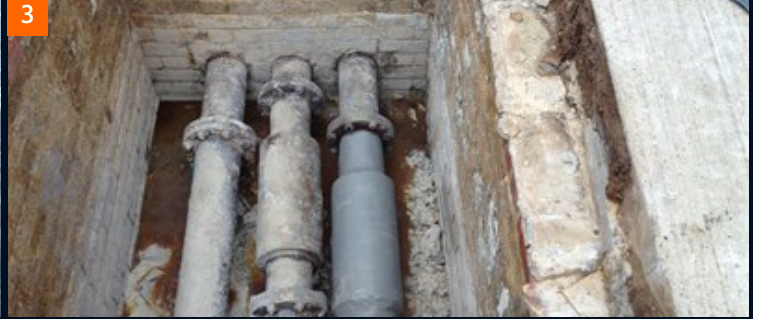
3. Completed application
