# BELZONA 1321 INJECTS NEW LIFE INTO OLD SHAFT

3" diameter shaft on the canning line of a local brewery

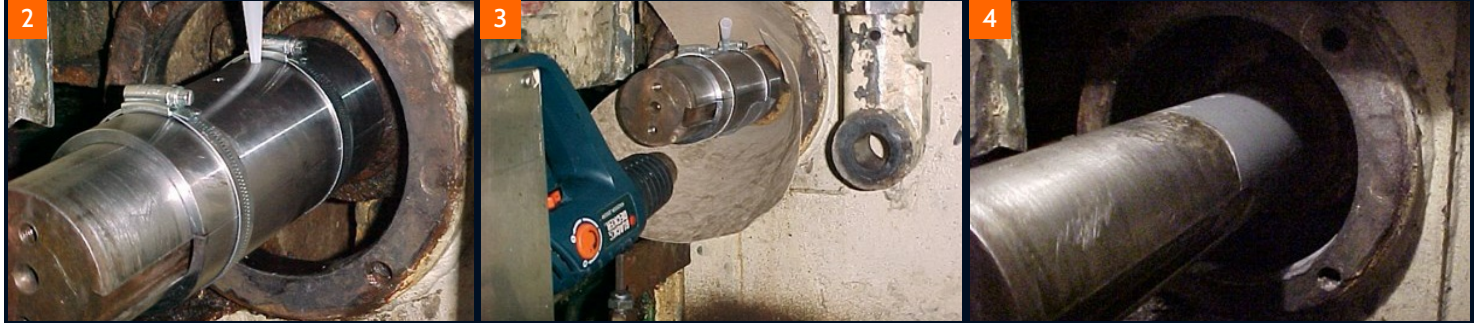
A collapsed bearing had caused excessive wear to the shaft necessitating either a full repair or replacement.

1. The shaft location showing restricted access
2. The former in place with nozzle for venting
3. Post curing the repair to reduce downtime
4. The finished shaft

Replacement of the shaft was considered the only alternative - the problem being it was costly and time consuming, around £20,000 (\$40,000) for a new shaft and five days of downtime. The Belzona solution was carried out in under one shift period thanks to the ability of Belzona to be post-cured and is still working today.
