# CONDENSER REPAIRED WITH BELZONA

ID: 5156

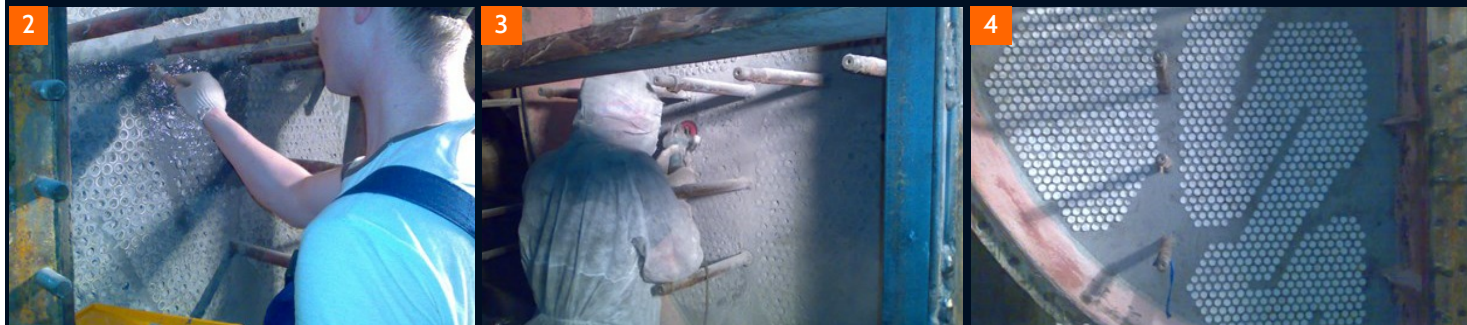
## PHOTOS

1. Grit blasting of the metal
2. Corks placed in the holes, application of Belzona 1311
3. Machining of the finished application
4. Application of Belzona 1321
