# BELZONA REPAIRS AND PROTECTS A HEAT EXCHANGER AGAINST EROSION/CORROSION

ID: 5160

Oil refinery "Ukratnafta" in Kremenchug city, Ukraine

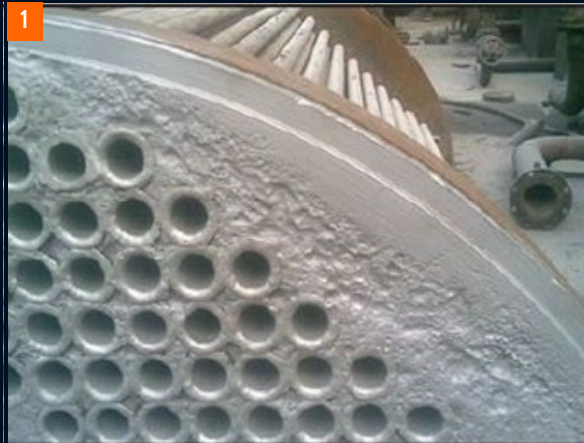
Erosion/corrosion on surfaces of the heat exchanger

1. Erosion/corrosion of the heat exchanger
2. Geometry repaired using Belzona 1311
3. Repaired surfaces of the heat exchanger after the application of Belzona 1311 and Belzona 1391
