# BELZONA REPAIRS CORRODED TANKS

ID: 5168

Storage tanks for molten bitumen

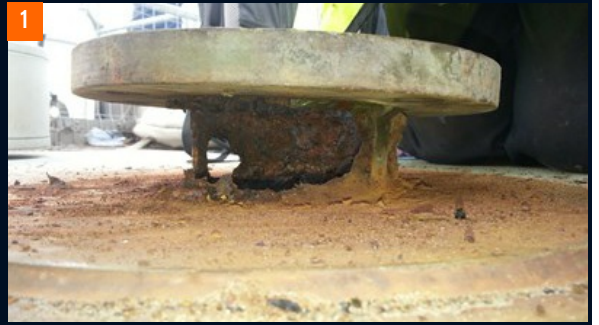
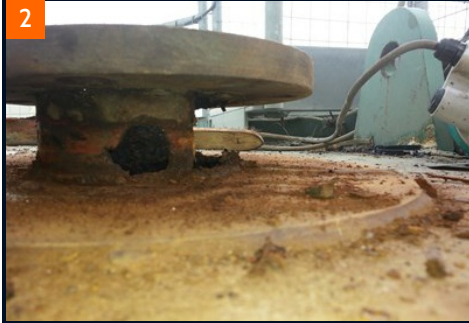
The tanks have a sensor on top for flow and level readings. They sit on an upstand with a bolted flange. The upstands had been eaten away by the corrosive fumes from the hot bitumen. They were holed through and the gases from the tanks were venting to the atmosphere.

1 & 2. Views showing the degree of corrosion present 3 & 4. Completed applications

The repairs were carried out in accordance with Belzona System Leaflet TCC-1. After preparing the corroded substrate, bridging tape was applied to span the holes so that product did not fall into the tanks. Three 4mm steel plates were bonded around each upstand before overwrapping with further Belzona incorporating Reinforcement tape.
