# BELZONA INTERNAL LINING TO PROTECT OFFSHORE PROCESS VESSELS

ID: 5170

New build vessel, corrosion and erosion protection

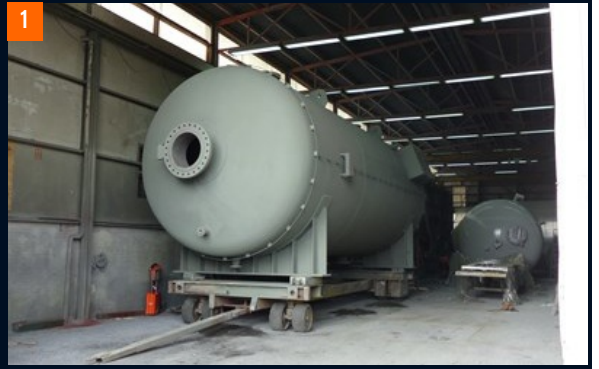
1. View of the HP Separator
2. Surface preparation completed and identification of the areas to be stripe coated
3. Spray application in progress
4. Completed application after inspection
