# BELZONA SEALS TRANSFORMER MAIN FLANGE

ID: 5171

## PROBLEM

The main flange was discharging high volumes of oil through the failing gasket system. In addition, the top and bottom bolt heads were also leaking. Continual tightening of the bolts over the years was no longer proving effective on the aged transformer. The Client sought a comprehensive, long term solution to seal the main flange and bolt heads.

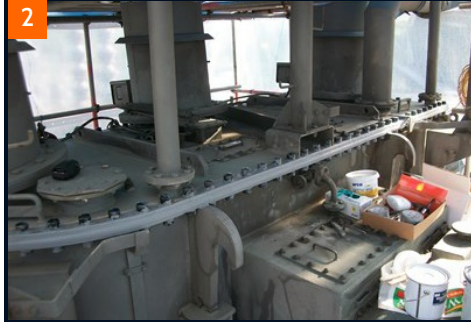
1. Transformer location
2. Preparation & cap fitting
3. Cap removal
4. Coating with Belzona 5831 to complete the application

Application was carried out in accordance with Belzona Know-How System Leaflet VPF-11. Due to a strict outage period and to enhance full success, the Client dropped the oil level beneath the flange level and created the correct working habitat and heat source to reduce product cure time. The flange joint was sealed by applying Belzona 1161 & Belzona 9341 (Reinforcement Tape). The bolt heads were fully encapsulated using a disposable former containing Belzona 1161. Once cured the former removed and the prescribed areas coated with Belzona 5831.
