# PICKLE TANK REPAIRED USING BELZONA PLATE BONDING

ID: 5172

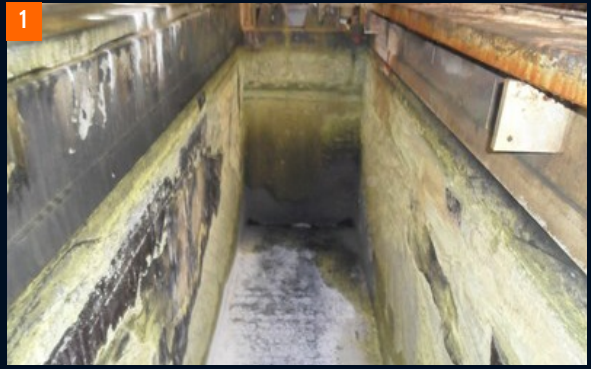
1. Tank location
2. Pre-start
3. Area preparation & pre-coated plate
4. Application completed

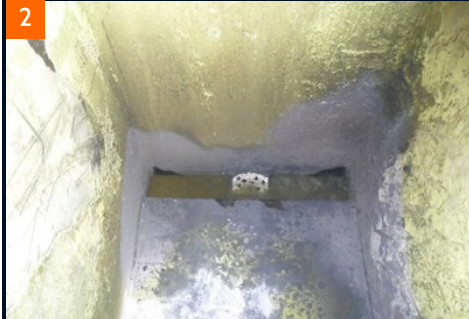
Corrosion issues prompted the Client to seek a cost effective solution to seal an internal-to-external drainage outlet. A swift application was required to eliminate any uncontrolled discharges of the acid to the internal working area.
