# BELZONA REPAIRS SHAFT FOR FRENCH NAVY

ID: 5174

Motor shaft on the frigate "Jean de Vienne"

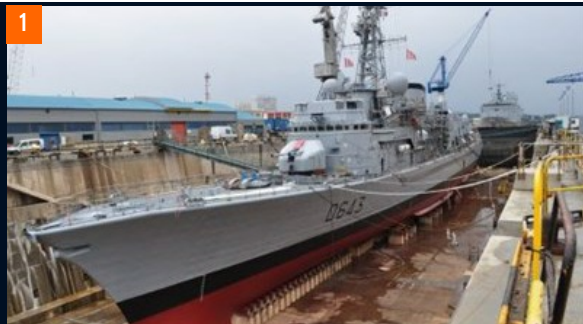
The tapered shaft had serious damage.

1. Frigate "Jean de Vienne" in drydock
2. Equipment with the damaged shaft
3. Close up of the damage on the shaft
4. Shaft after rebuilding with Belzona 1111 and machining

Application was carried out in accordance with Belzona Know-How System Leaflet MPT-1. The repair was machined to obtain a smooth finish.

The shaft was recovered back to serviceable condition with minimal downtime ensuring vessel was not delayed in drydock.
