# BELZONA WEATHERPROOFS TWO SUGAR SILOS

ID: 5175

Two sugar silos within the sugar factory required weatherproofing

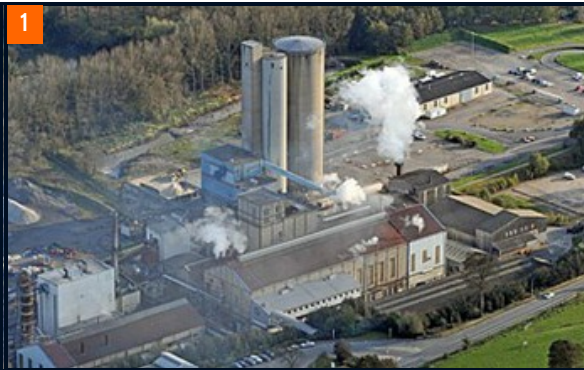
Infiltration of water into the tank through the porous concrete.

1. General view of the sugar plant
2. On-going application
3. Finished application
4. 6 years after the application

Application was carried out in accordance with Belzona System Leaflet WPA-1. The work was completed by applying the system in vertical stripes of 6 meter width.

The Belzona 3111 system is proven to provide excellent long term weatherproofing of substrates. The application was carried out in 10 weeks with a team of 7 applicators. The silos have been revisited after 2 years and 6 years later, the application was still in perfect condition.
