# BELZONA REFURBISHES CORRODED COMPRESSOR HOUSING

ID: 5176

Advanced corrosion on the bottom of the compressor housing.

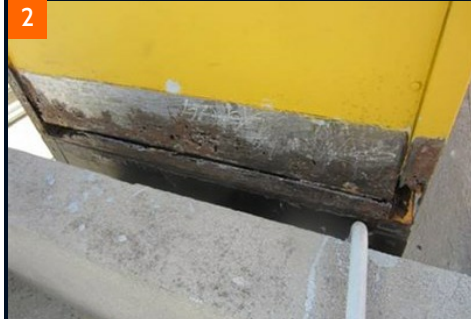
1. Before repair
2. After surface preparation of the area
3. Doubler plate bonded in place
4. Finished application with Belzona 5811 applied over the corroded area
