# BELZONA REPAIRS DAMAGED PIN BUSH HOUSING

ID: 5180

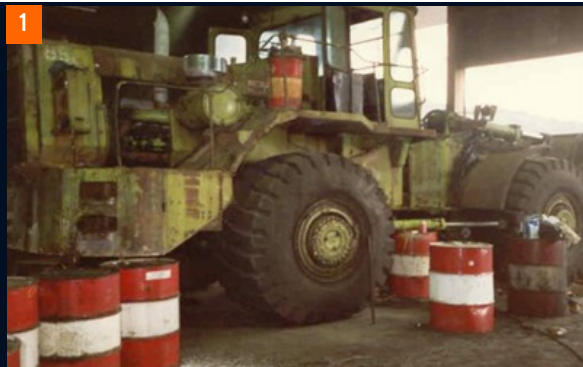
1. View of Terrex HD Equipment
2. Preparation of worn bush housing in progress
3. New pin bush and bearings coated with release agent
4. Completed application

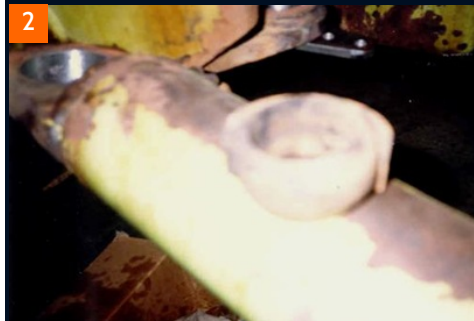
Bush housing holding articulating hydraulic arm would wear constantly requiring welding and line boring. Construction of bearing also presented a problem when inserting into housing. Because of the tight tolerances it would easily deform.

Wear on bush housing.

Application carried out in accordance with Belzona Know-How System Leaflet MPT-8
