# BELZONA REPAIRS DAMAGED CLIP JOINT

ID: 5181

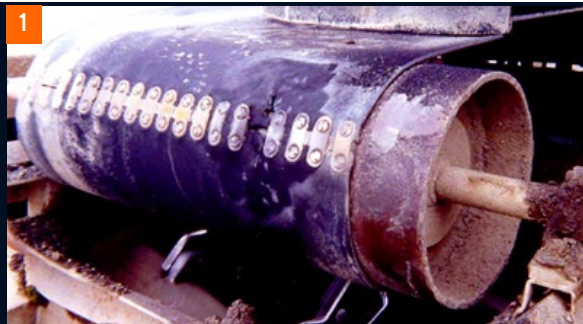
Clip joint had started to separate and tear.

1. View of damaged clip joint
2. Completed application.
