# BELZONA REPAIRS SCORED HYDRAULIC RAM

ID: 5183

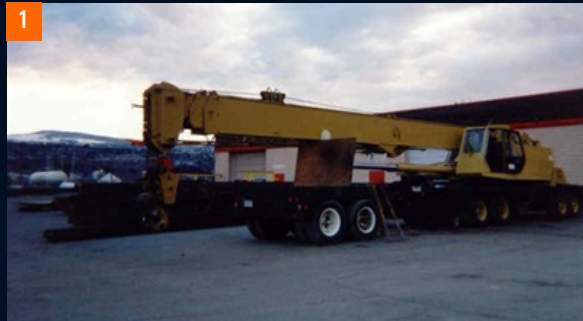
Hydraulic rams had been subjected to sever mechanical damage around the seal area, rendering them ineffective. This was the only heavy duty lifter used for loading on site. New ram was not immediately available.

1. View of damaged ram
2. Damaged areas "V" out
3. Rebuilt with Belzona 1221
4. Completed repair.
