# BELZONA REBUILDS MAIN PIVOT SHAFT ON SITE

ID: 5185

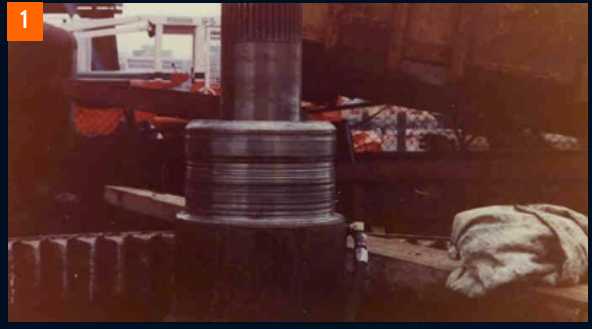
Original bearing had badly worn the main pivot shaft of this excavating crane.

1. View of preparation in progress
2. Application in progress.
3. Completed application with mold still in place. Mold removed after material had set up leaving a remolded bearing surface.

Application carried out in accordance with Belzona Know-How System Leaflet MPT-2
