# EXPANSION JOINTS REPLACED AT WASTEWATER PLANT

Primary Wastewater clarifier.

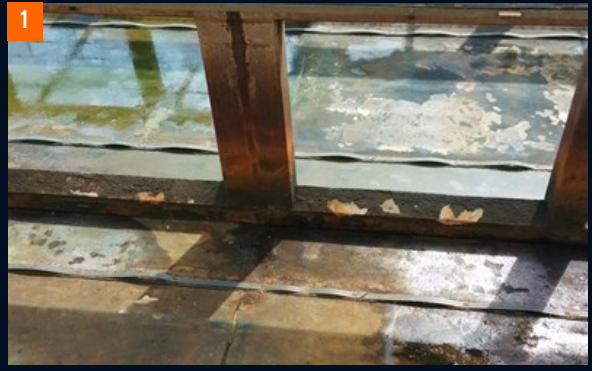
Existing joint material had become defective allowing leaking of fluid.

1. Prior to application
2. Preparation
3. Application
4. Completed application

Application was carried out in accordance with Belzona Know How System Leaflet FPA-6 for replacing expansion joint sealant, WPA-4 for rebuilding vertical and overhead masonry substrates, WPA-9 for repairing vertical building joints. After removing existing failed expansion joints the deteriorated vertical nosings were rebuilt using Belzona 4141 and replaced the expansion joints using Belzona 2211. The horizontal existing failed expansion joint were removed and replaced using Belzona 2211.
